Manhole Inspection Summary

Manhole # S49AA_023MH

Insp Date: **7/10/08 9:35 AM**

Location Address: **McElderry**

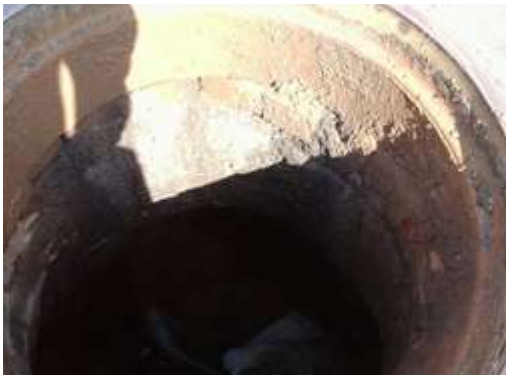
Defect 2

Infiltration: ☐ None ☐ Joint ☐ Cracks ☐ Mortar ☐ Roots ☒ **Wall**

wall

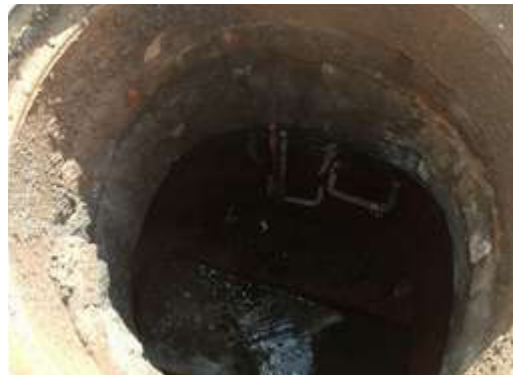
Defect 1

Count: **4** Missing: **2** ☒ **Corroded**

steps

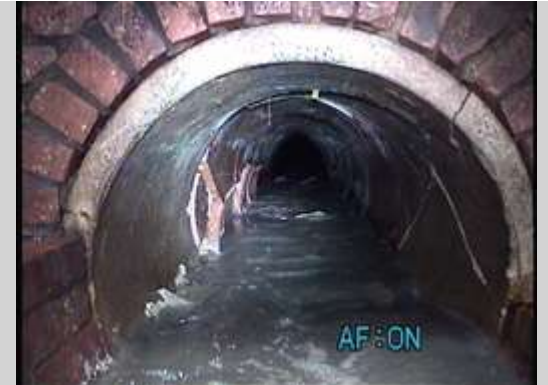
12 O'Clock Outflow

24 in. Circular Gravity Sewer
Pipe Out @ 12 O'Clock

Pipe Height: **24** (in.) Rod and Bar (Angled)
Pipe Material: **Clay** ☐ Pipe Lined
Invert Depth: **9.50** (ft.) Flow Characteristics: **Fast**
Deposits: ☒ None ☐ Mud ☐ Sludge ☐ Debris ☐ Grease
Silt Depth: (in.) Deposits Extent:
Infiltration: **None** Pipe Seal Cond: **Sound**

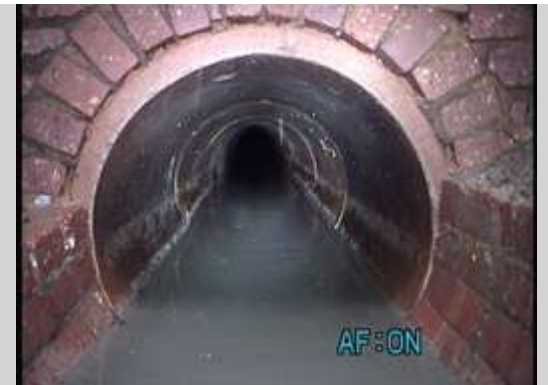
6 O'Clock Inflow

21 in. Circular Gravity Sewer
Pipe In @ 6 O'Clock

Pipe Height: **21.6** (in.) Rod and Bar (Angled)
Pipe Material: **Clay** ☐ Pipe Lined
Invert Depth: **9.35** (ft.) Flow Characteristics: **Fast**
Deposits: ☒ None ☐ Mud ☐ Sludge ☐ Debris ☐ Grease
Silt Depth: (in.) Deposits Extent:
Infiltration: **None** Pipe Seal Cond: **Sound**

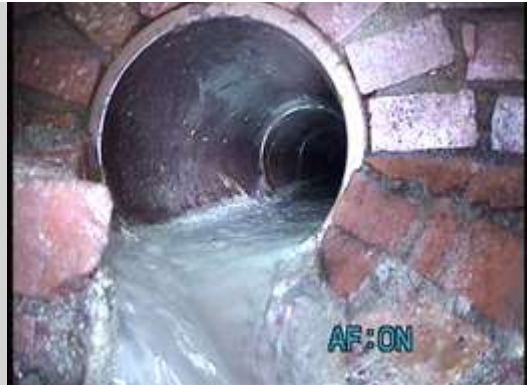
9 O'Clock Inflow

10 in. Circular Gravity Sewer

Pipe In @ 9 O'Clock

Pipe Height: **10.8** (in.) Rod and Bar (Angled)

Infiltration: **None** Pipe Seal Cond: **Sound**
